**2024 ROADWAY EVALUATION SURVEY**

**TOWN OF RIVER BEND  
CRAVEN COUNTY, NORTH CAROLINA**

**Avolis Engineering, PA  
P.O. Box 15564  
New Bern, NC 28561  
(252)633-0068 Office**

**March 18, 2003  
Updated May 16, 2007  
Updated January 29, 2008  
Updated July 22, 2024**

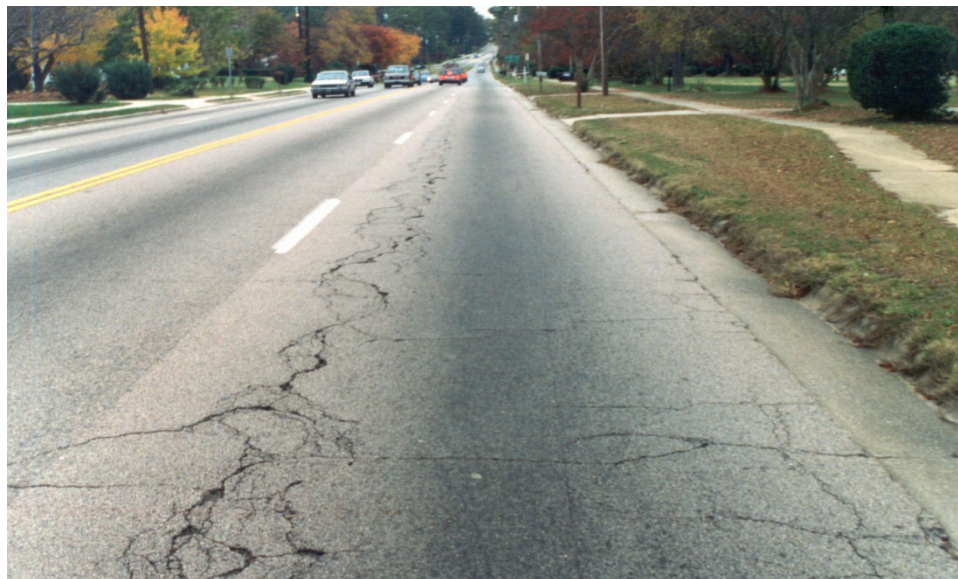
### **A. Alligator Cracking**

Alligator cracking is a load associated structural failure. The failure can be either in the surface, base or subbase. Permanent deformation (rutting) does not have to be present for there to be alligator cracking. Cracking first begins in the wheel path, usually as longitudinal cracking. Further stress creates an alligator pattern. If the surface is very flexible, the longitudinal crack will become wider and an alligator pattern may not develop until severe distress sets in. The proper corrective measure for both alligator and longitudinal cracking is the same since a structural failure is taking place in both cases. Alligator cracking also includes cracking along the pavement edge.

Alligator cracking is rated based upon the percentage of pavement area exhibiting cracking at different degrees of severity (i.e. 10% - None, 30% - Light, 60% - Severe).

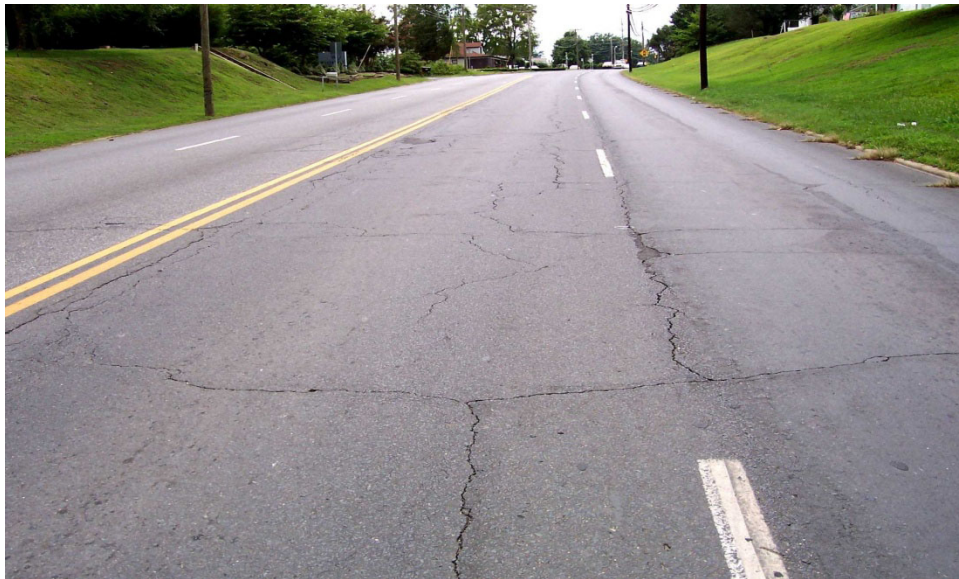
## B. Transverse Cracking

Block cracks divide the pavement up into roughly rectangular pieces. Block cracking is not load-associated. Cracks are generally caused by shrinkage of the asphalt concrete and daily temperature cycling. Wheel path loads can increase the severity of block cracking if water is allowed to penetrate into the cracks. It is therefore very important to seal these cracks to prevent water penetration into the base materials.

- (L)ight:** Cracks, usually only transverse, are less than ¼-inch wide and are not spalled: block pattern may not be visible yet; transverse cracks usually 10 to 20 feet apart. Cracks have little or no spalling and joints are usually not bumped up.
- (M)oderate:** Block pattern may be visible with blocks 10 square feet or greater present; cracks are ¼-inch and ½-inch wide; cracks may or may not be spalled; transverse cracks usually 5 to 20 feet apart
- (S)evere:** Cracks may be severally spalled with smaller blocks 2 to 10 square feet present; cracks usually greater than ½-inch wide; transverse cracks may be 1 to 2 feet apart throughout portions of the surface.

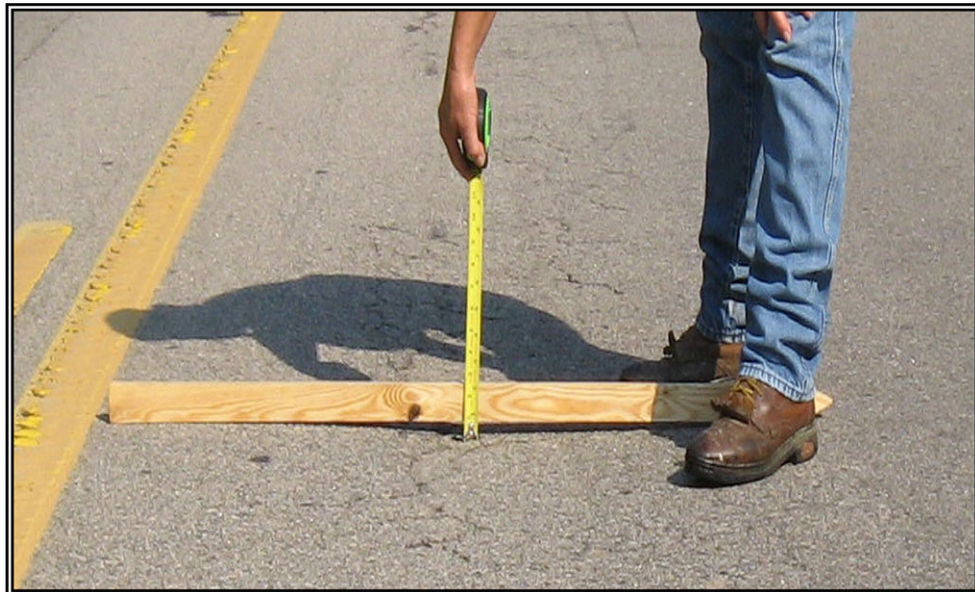
### C. Rutting

A rut is a surface depression in the wheel path(s) or at the edge of pavement. Rutting comes from a pavement deformation in any of the pavement layers or in the subgrade, usually caused by consolidation or lateral movement of the materials due to traffic loads. Movement in the mix in hot weather or inadequate compaction during construction is the main cause of rutting.

**(M)oderate:** Rutting  $\frac{1}{2}$  to less than 1-inch deep.

**(S)evere:** Rutting 1-inch deep or greater.

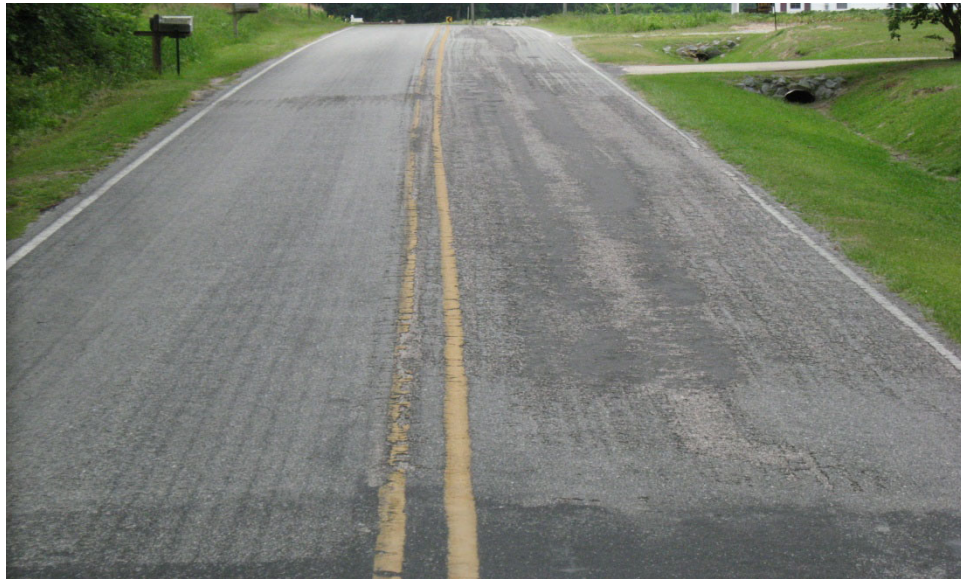
## D. Raveling

Raveling is the wearing away of the pavement surface caused by the dislodging of aggregate particles or loss of asphalt binder. Raveling is more common on slurry surfaces than on plant mix surfaces. Raveling indicates either a hardening or poor application of asphalt binder.

- (L)ight:** Aggregate loss is not great; small amounts of stripping may be detected; aggregate has started to wear away.
- (M)oderate:** Some stripping evident, random stripping with small areas (less than one square foot) or strips of aggregate broken away.
- (S)evere:** Stripping very evident; aggregate accumulations may be a problem; large sections (greater than one square foot) of stripping with aggregate layer broken away.

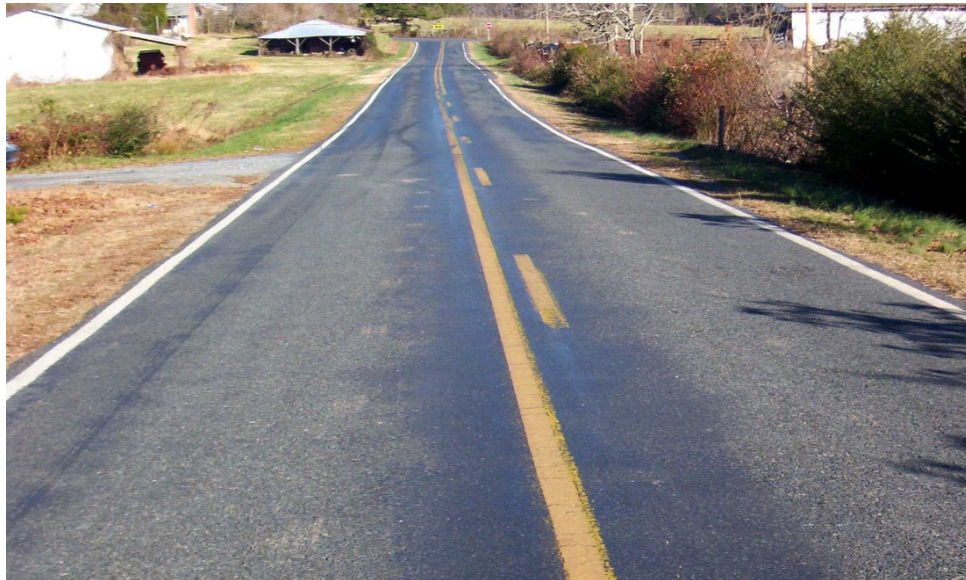
## E. Bleeding

Bleeding is a film of bituminous material on the pavement surface that creates a shiny, reflective surface. Bleeding is caused by excess asphalt cement in the mix and/or low air void content. During hot weather the asphalt fills the voids of the mix and then expands out onto the surface of the pavement.

**(L)ight:** Condition is present on 10 to 25 percent of the section.

**(M)oderate:** Condition is present on 26 to 50 percent of the section.

**(S)evere:** Condition is present on greater than 50 percent of the section.

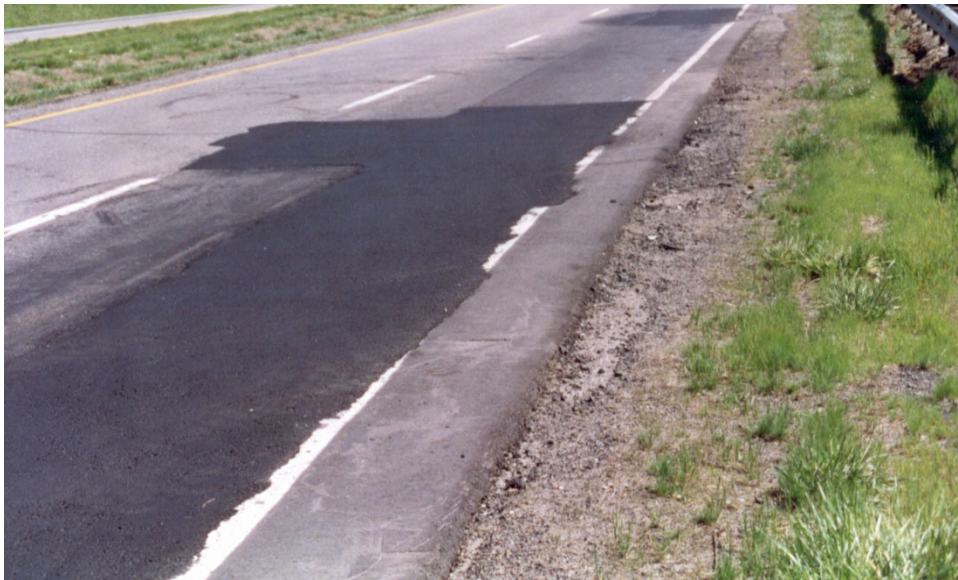
## G. Patching

Patching is defined as any surface area of the existing pavement that indicates some type of maintenance repair has taken place. These patched areas may be skin patches, edges, overlays or full depth patches. They may be in spot locations, along one or both edges, in the wheel paths, across the entire surface for short distances, or a combination of any of these. The quality and condition of the patch is not considered in evaluating patching. It does not matter if all the patches are alligator cracked, rutted or potholed. These conditions are measured in the other distresses. Patching is an indication of the amount of surface area that has received some type of maintenance repair that may or may not be holding up.
